Technical Service Bulletin

SUBJECT: SOFTWARE UPDATE FOR NEW OR REPLACEMENT ROCKFORD FOSGATE AMPLIFIER (DAS) - REVISED			No: TSB-19-54-012
			DATE: May 2019
			MODEL: 2015-19 Mirage, 2019 Mirage G4
CIRCULATE TO:	<input type="checkbox"/> GENERAL MANAGER	<input checked="" type="checkbox"/> PARTS MANAGER	<input checked="" type="checkbox"/> TECHNICIAN
<input checked="" type="checkbox"/> SERVICE ADVISOR	<input checked="" type="checkbox"/> SERVICE MANAGER	<input checked="" type="checkbox"/> WARRANTY PROCESSOR	<input type="checkbox"/> SALES MANAGER

This bulletin supersedes TSB-16-54-003, issued September, 2016, to add Mirage G4, additional model years for Mirage, and update affected part numbers. Revisions are italicized and indicated by ◀.

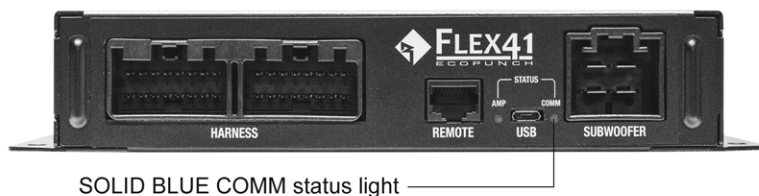
1. Before plugging the USB thumb drive assembly into the Flex41 amplifier, turn on the vehicle's accessory electrical system (turn key or push start button to engage the ACC mode).
2. Check to see that the amplifier is powered ON and the COMM status light is SOLID BLUE.

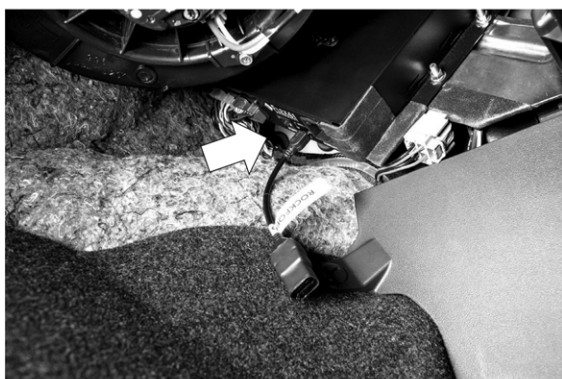
3. Plug the USB thumb drive assembly into the USB jack on the front of the Flex41 amplifier. The amplifier is located on the passenger side of the vehicle above the kick panel.

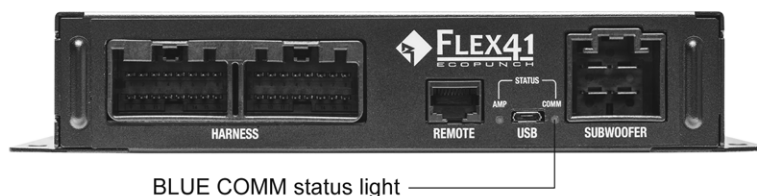
- When the update is complete. Unplug the USB thumb drive assembly and the amplifier will reset and turn back on (AMP STATUS light is SOLID BLUE). The amplifier has been successfully re-programmed.
