**** TECHNICAL INFORMATION NOTICE ****

DATE: May 2, 2018
TO: Mitsubishi Motors US & Puerto Rico Dealer Service and Parts Managers
RE: *Display Audio System w/Smartphone Link* (DAS) Software Update for Rear View Camera Freezing Issue
TIN NO. TIN-18-54-003REV

AFFECTED VEHICLES: 2017 Lancer Limited Edition, Mirage, Mirage G4, Outlander Sport Limited Edition

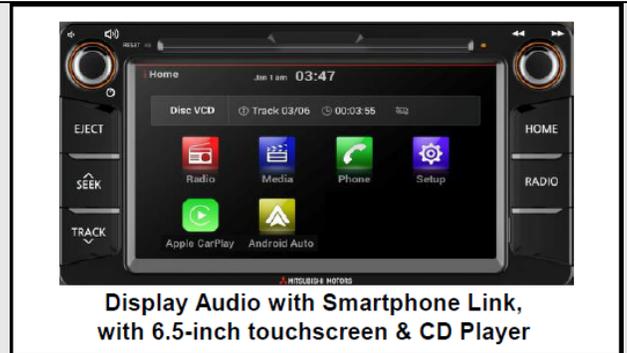
1. *Verify the head unit is the type shown at right.*

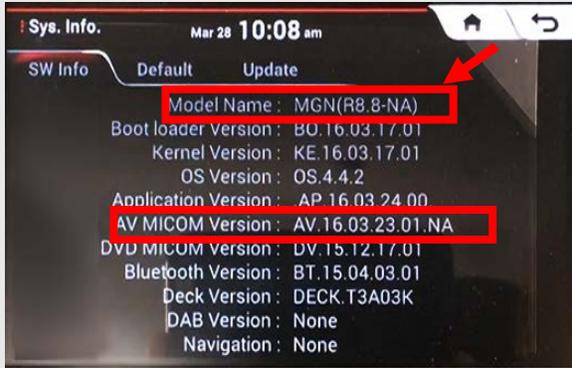
Example of Older Version

2. Check the software version to verify the unit has not been updated. The software needs to be updated if the numerical value is **prior** to the Model Name and AV MICOM versions below:

Model Name: MGN(R11.1-NA)
AV Micom Version: AV.17.04.13.04.NA

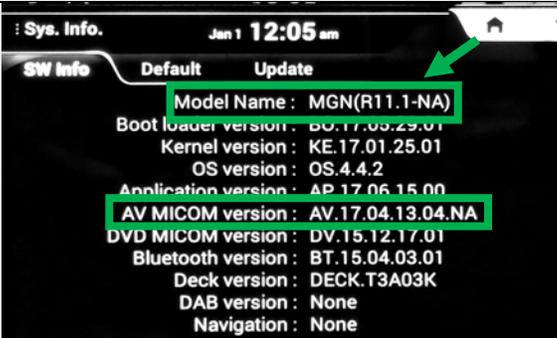
<p>29. Check the software version. It should be the Model name and AV Micom Version shown below.</p> <p>Model Name: MGN(R11.1-NA) AV MICOM Version: AV.17.04.13.04.NA</p>
