## Issue: No Heat from Right Side – Heater Core Restricted

2014-2015 Mitsubishi Mirage

## Case Study: 2014 Mitsubishi Mirage

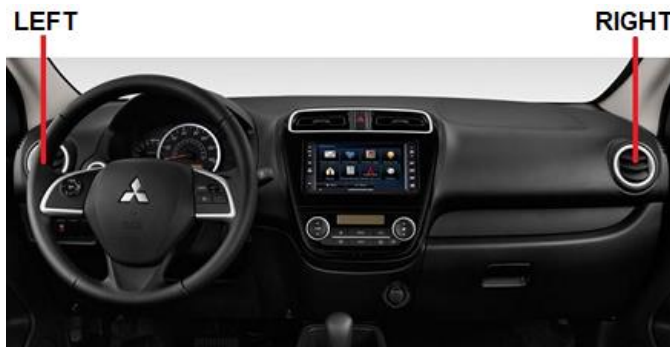
Figure 1: Mirage Left and Right Instrument Panel Vents

1. Place a temperature probe into the left and right instrument panel vents (Figure 1).

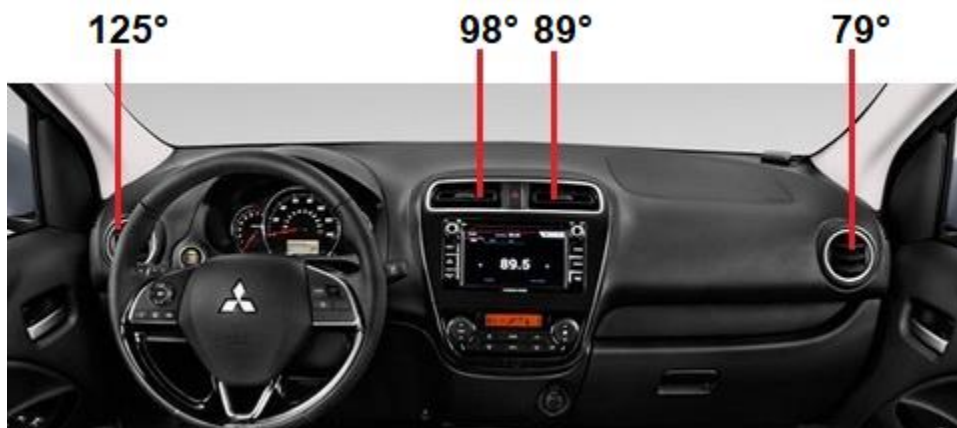
Figure 2: 2014 Mirage Heat Temperatures with OEM Heater Core

A Mirage with an internally restricted heater core will exhibit poor heat output and a distinct temperature decline from left to right across the instrument panel. Figure 2 below shows the heat temperatures observed in a 2014 Mirage *with its original heater core and engine coolant*. The pattern of declining temperatures from left to right can be seen in this example...

**Vehicle:** 2014 Mitsubishi Mirage  
**Odometer:** 77,000 miles  
**Coolant:** 195° F  
**Ambient:** 25° F

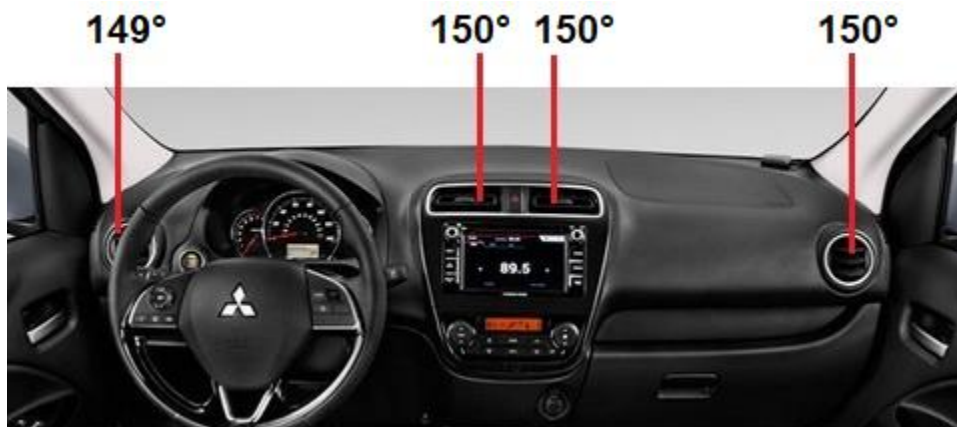
Figure 3: 2014 Mirage Heat Temperatures with Replacement Heater Core

Below are the output temperatures of this Mirage **after** replacing the OEM heater core:

Mirages with unrestricted heater cores produce adequate heat in cold temperatures with no temperature variation across the instrument panel.

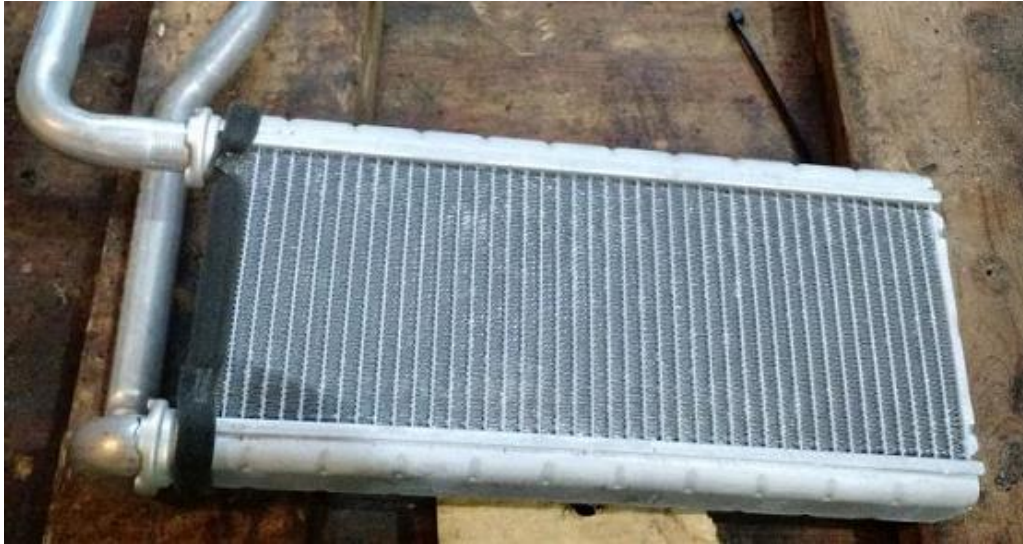
Here is the OEM heater core removed from the vehicle...

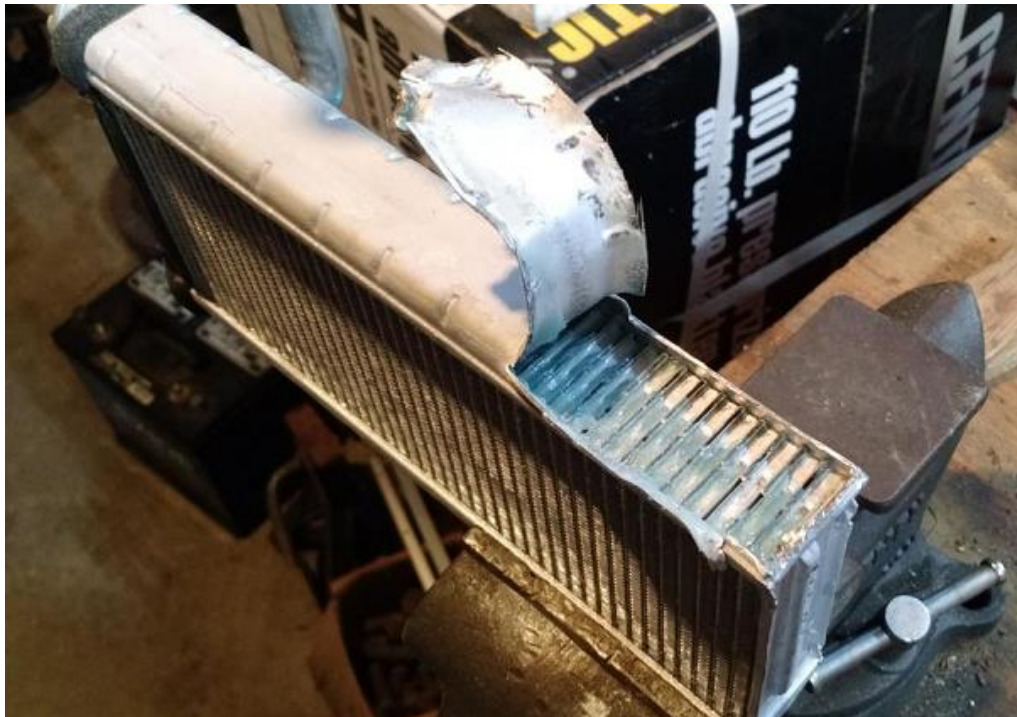
Here is the tank removal process in progress. Snips were used to carefully open the tanks without disturbing the internal structure of the heater core...

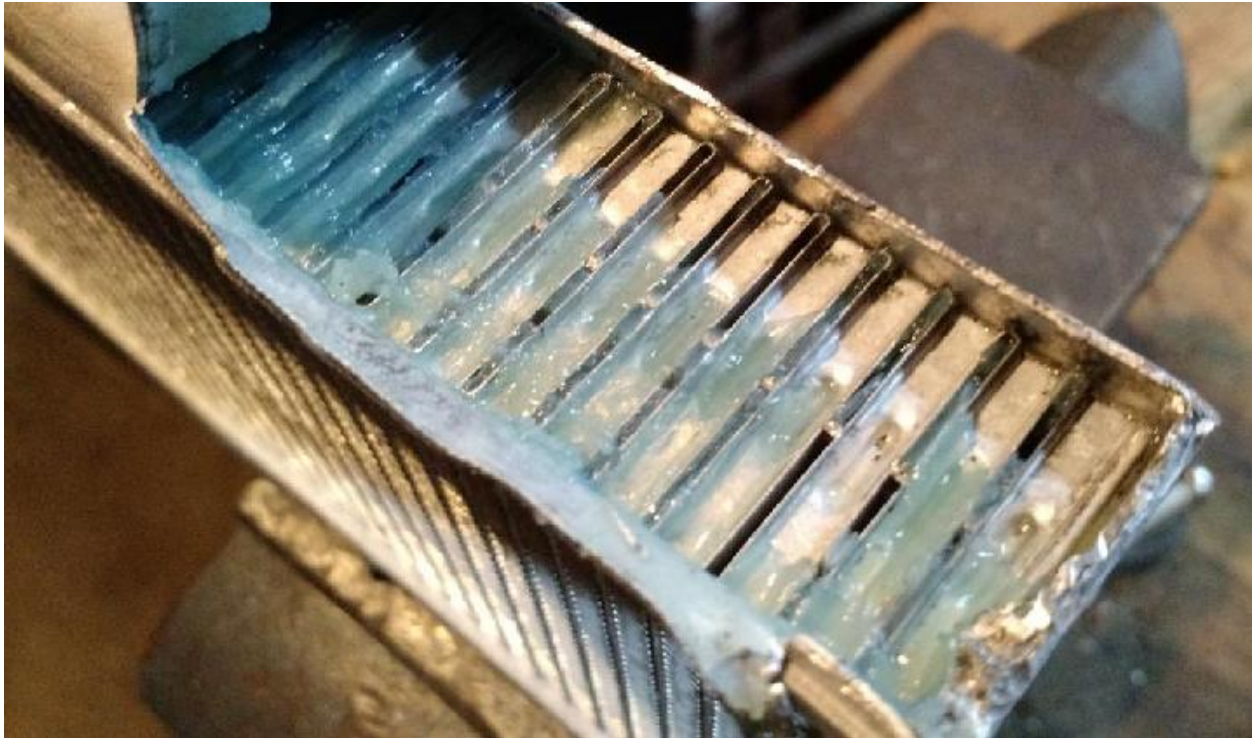
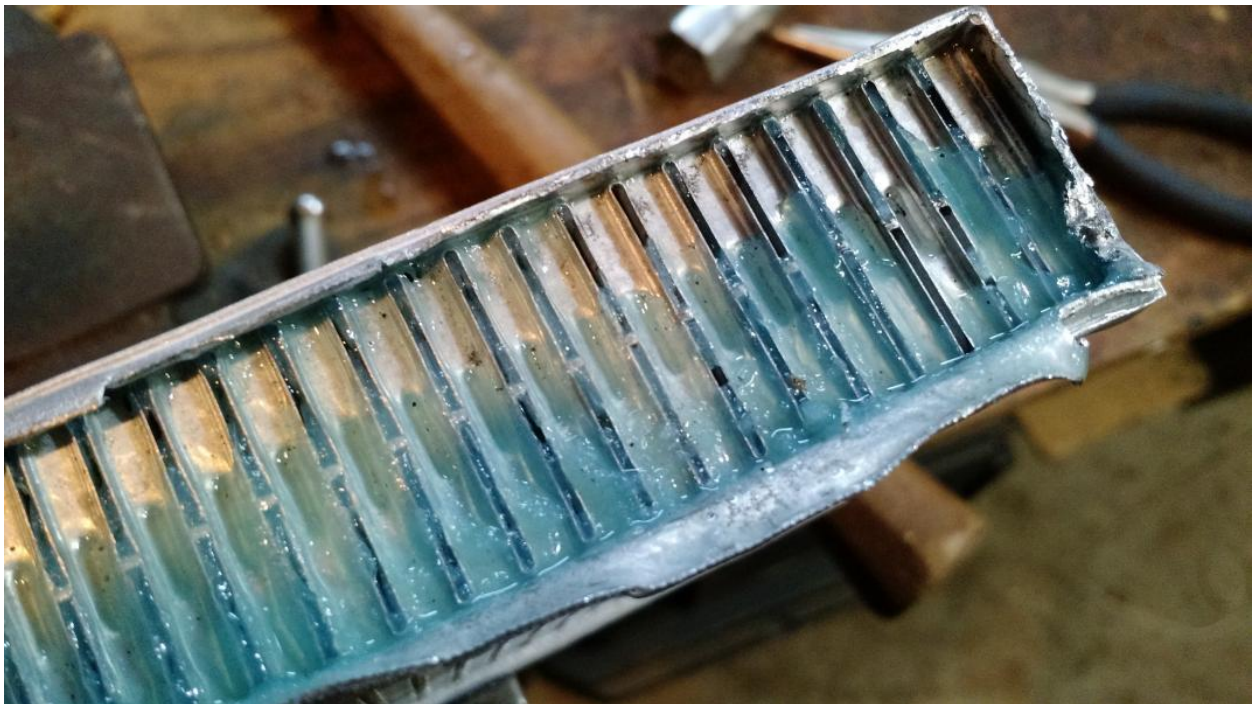
Below are two photos of the **outlet** side of the heater core. An unknown substance is present in this area resulting in a coolant flow restriction on the right (passenger) side of the core...

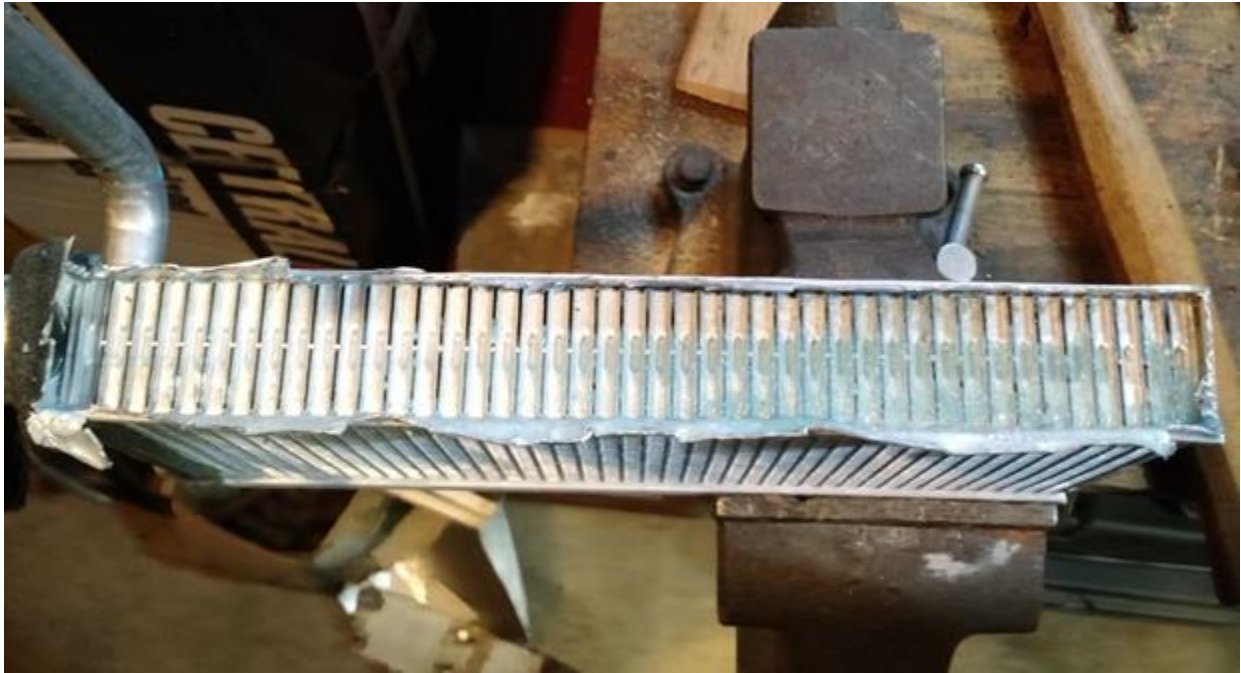
Here is a view with the entire **outlet** side of the heater core exposed. The unknown substance is present on nearly all of the right (passenger) half of the core...

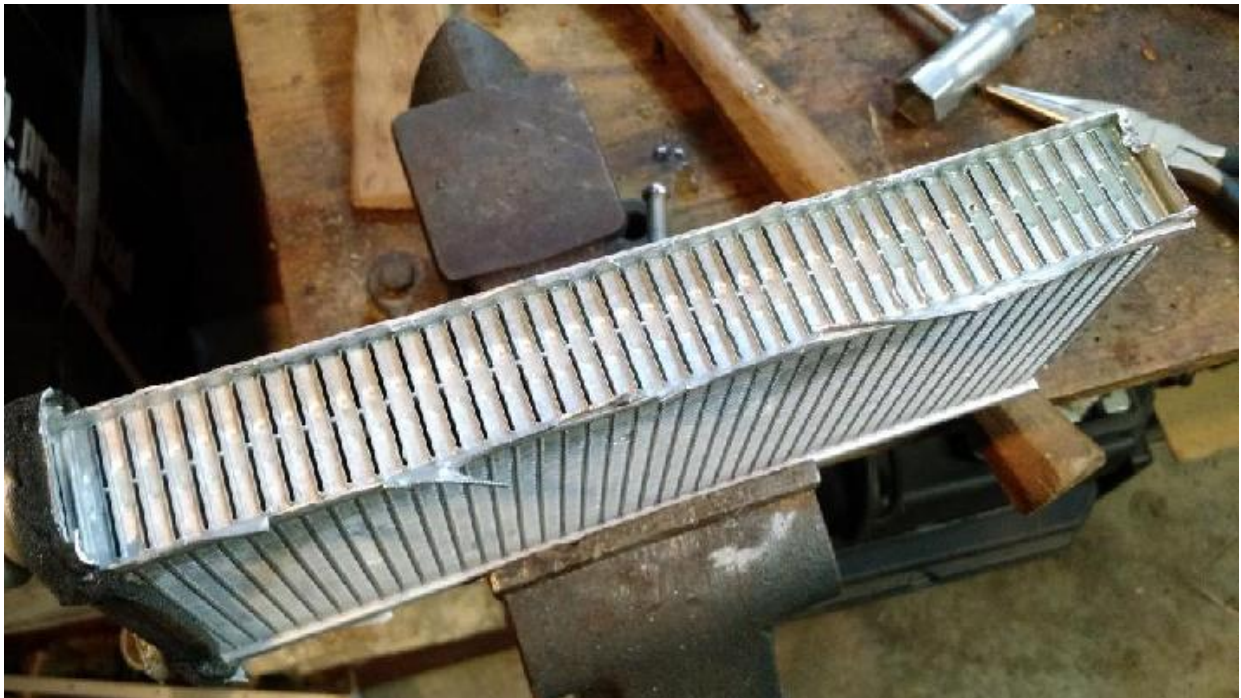
Here is a view of the **inlet** side of the heater core. It shows a much smaller amount of the unknown substance compared to the outlet side...

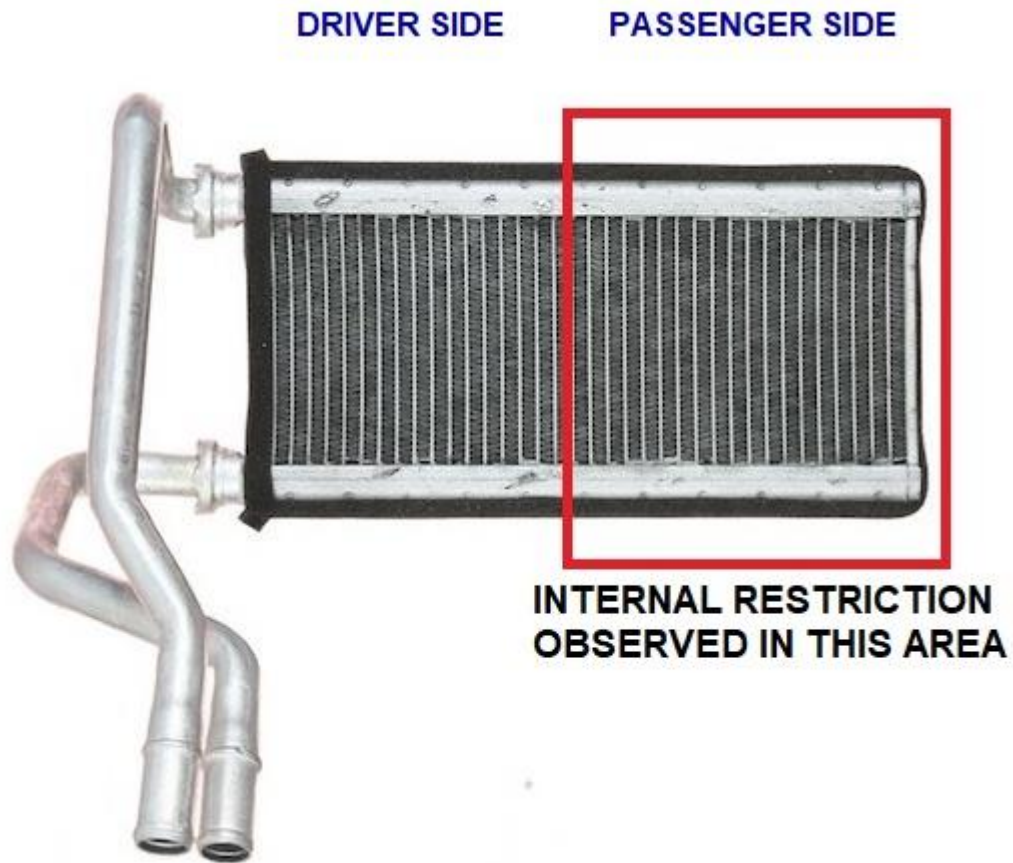
This image shows where the area of restriction was identified in the OEM heater core...

This examination of the OEM Mirage heater core confirms that an internal restriction on the passenger side of the core was the cause of reduced heater output in this vehicle. The restriction has resulted from an unknown substance collecting on the outlet side of the heater core passages. Replacement of the OEM heater core restored this vehicle's normal heater output.

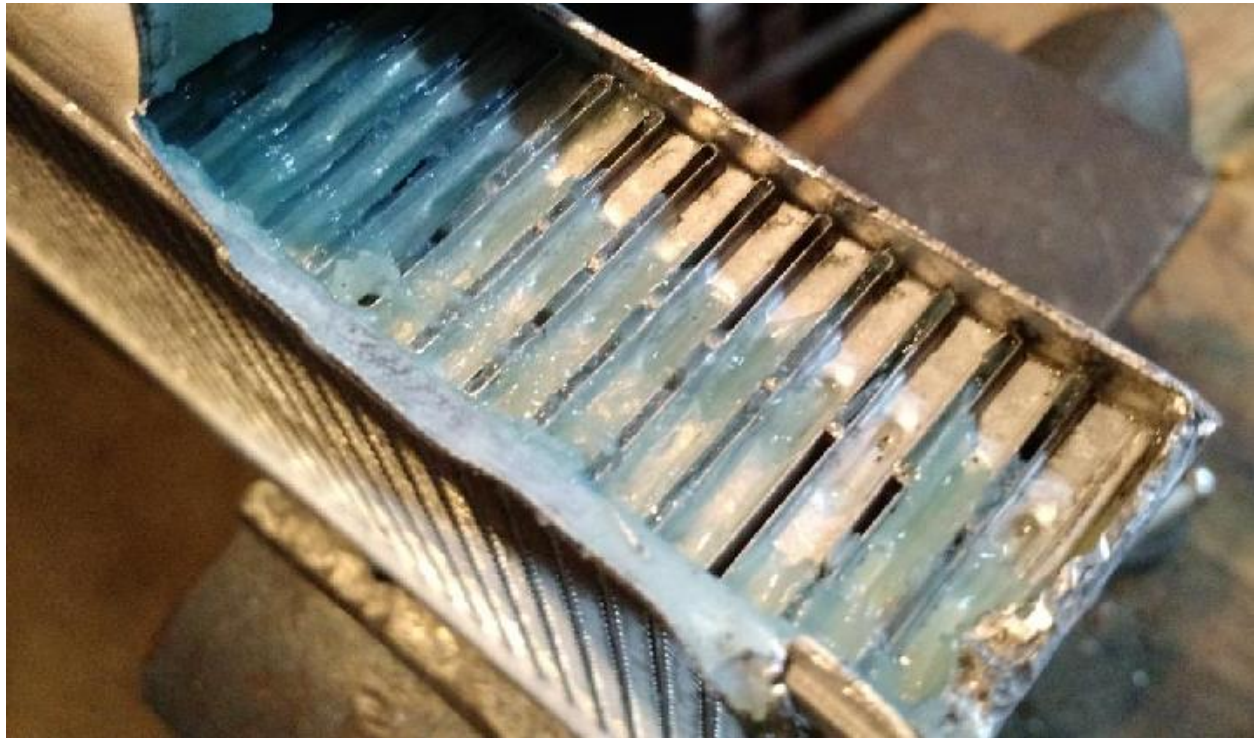
The OEM heater core examined had an unknown substance which had collected on the passenger **outlet** side of the core. This material has a consistency similar to petroleum jelly...

*"We can't say anything definite without an analysis of the material. However, the substance may be created within the heater core itself, the cause being residual substances used in manufacturing that react with the OEM coolant and subsequently deposit the reaction product on the colder, outlet side of the heater core. We recommend replacing the affected heater core and using Glysantin G64 coolant in the future, which was designed specifically for preventing such deposits."*
