SERVICE CAMPAIGN BULLETIN

SUBJECT:			No: SC-16-001REV
ECM REPROGRAMMING FOR ENGINE KNOCKING NOISE – SERVICE CAMPAIGN – REVISED			DATE: March, 2016
			MODEL: 2014–15 Mirage
CIRCULATE TO:	<input checked="" type="checkbox"/> GENERAL MANAGER	<input checked="" type="checkbox"/> PARTS MANAGER	<input checked="" type="checkbox"/> TECHNICIAN
<input checked="" type="checkbox"/> SERVICE ADVISOR	<input checked="" type="checkbox"/> SERVICE MANAGER	<input checked="" type="checkbox"/> WARRANTY PROCESSOR	<input checked="" type="checkbox"/> SALES MANAGER

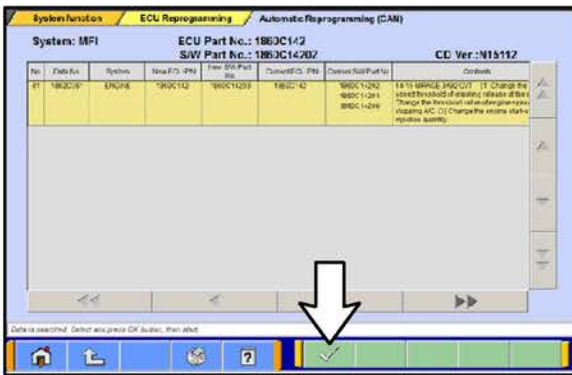
10. The Automatic Reprogramming (CAN) database screen will display.

- Verify that the new ECU and S/W part numbers are listed in the table.
- Confirm the database number at the top right of the table is N15112 or higher.
- If more than one row is displayed in the table, refer to the ECM Reprogramming Chart on page 2 to highlight and select the correct row.
- Click the check mark to continue.
