Technical Service Bulletin

SUBJECT:			No: TSB-18-52B-001
MIRAGE & MIRAGE G4 SRS WARNING LAMP ILLUMINATION DTC B1479			DATE: October 2018
			MODEL: See Below
CIRCULATE TO:	<input type="checkbox"/> GENERAL MANAGER	<input checked="" type="checkbox"/> PARTS MANAGER	<input checked="" type="checkbox"/> TECHNICIAN
<input checked="" type="checkbox"/> SERVICE ADVISOR	<input checked="" type="checkbox"/> SERVICE MANAGER	<input checked="" type="checkbox"/> WARRANTY PROCESSOR	<input type="checkbox"/> SALES MANAGER

On certain vehicles, the Supplemental Restraint System (SRS) Air Bag Warning Lamp illuminates with DTC B1479 (SRS-ECU Backup capacitor circuit voltage too Low.)

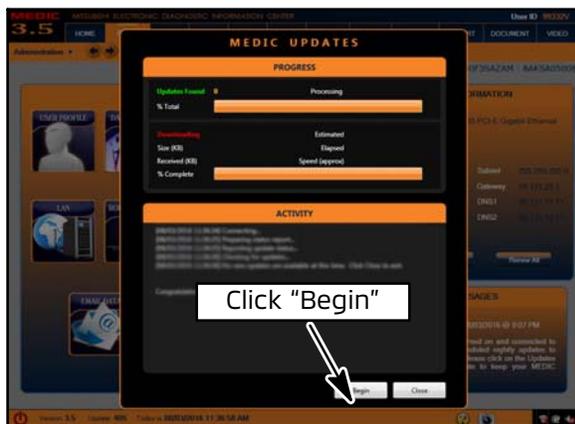
If your **MEDIC 3.5/4 update is below 557**, update your MEDIC as follows.

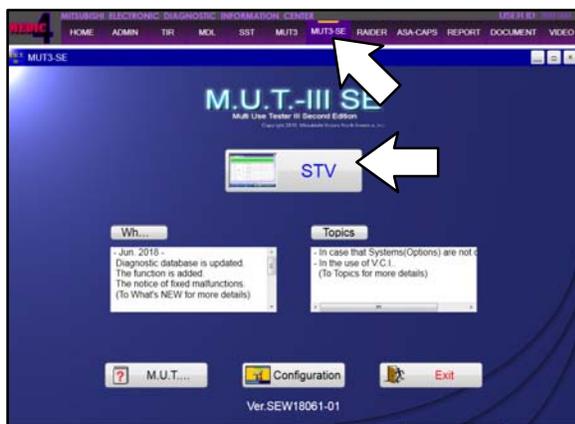
3. If the MEDIC update screen advises updates are available, click the "Begin" button. After all updates are complete, **GO TO THE REPROGRAMMING PROCEDURE.**

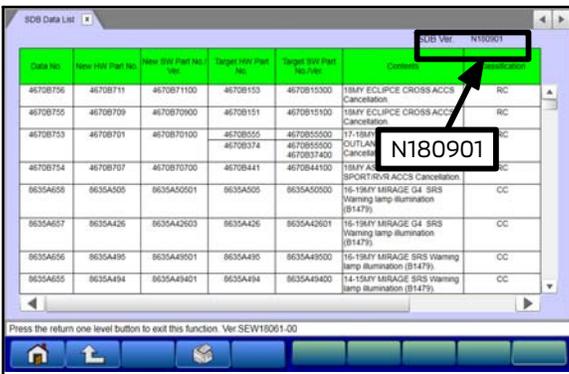
b. Click "SDB Data List."

- c. Confirm that the database number displayed in the upper right above the chart is **N180901** or higher
- If the database number displayed on your MUT3-SE is **N180901** or greater, continue to the "Reprogramming Procedure."
 - If the reprogramming database number displayed on your MUT3-SE is **lower** than **N180901**, then the MUT3-SE database needs to be updated.

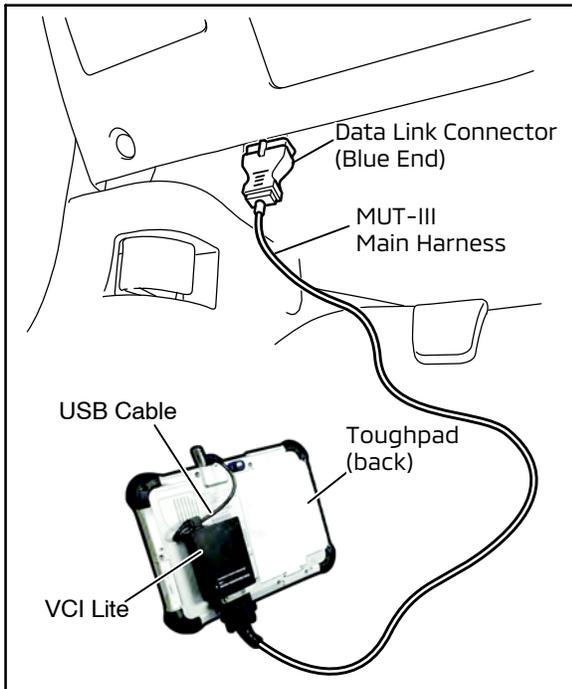
1. Connect the equipment as follows:

NOTE: VCI Lite and MEDIC 4.0 Toughpad shown for illustration purposes only.

- Turn the MEDIC PC/tablet on. If the battery indicator in the lower right hand corner of the screen does not show a full charge, it is recommended that either the battery be charged prior to beginning, or be used with the A/C power adaptor connected.
- Connect the USB cable to the VCI/VCI Lite.
- When the laptop/tablet displays the MEDIC main screen, connect the USB cable to the device.
- Connect the MUT-III main harness with the blue DLC connection to the VCI/VCI Lite.
- Connect the blue connection of the MUT-III main harness to the vehicle's data link connector.
- For VCI only (P/N MP991824): Turn the VCI power switch ON. Verify that the indicator lamp in the upper right corner of the screen is green.

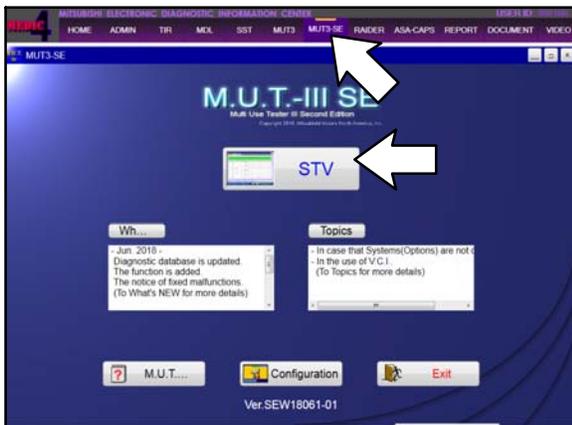
2. Turn the ignition switch to the "ON" position.

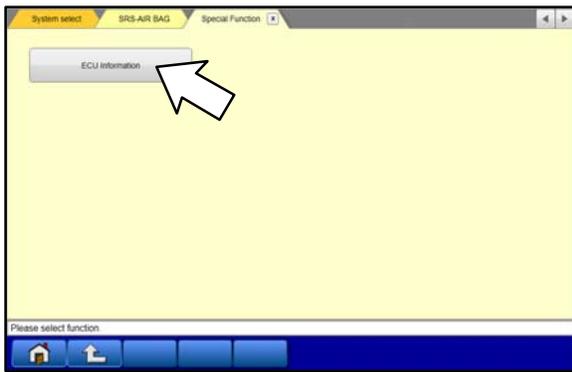
b. Select "Special Function."

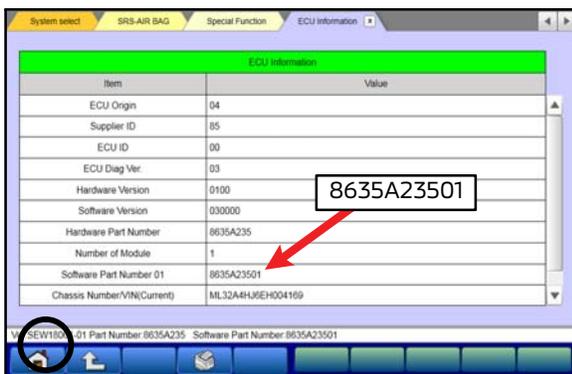
c. Select "ECU Information."

b. If the Software Part Number listed is **NOT** at the latest level (shown in the "**SRS-ECU Reprogramming Chart**"), proceed with the next steps.

10. Verify that the software Part Number is now at the latest number listed in the "SRS-ECU Reprogramming Chart" in this TSB.
For instructions, refer to step 5 in this TSB.

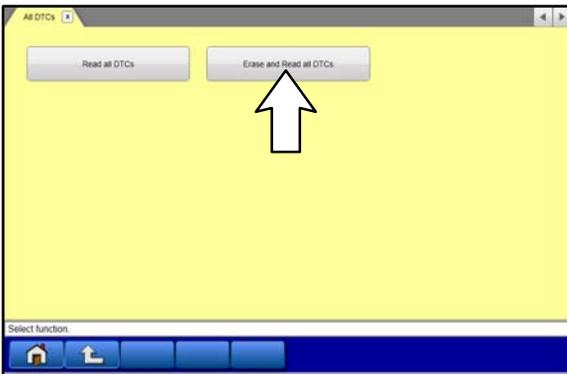
a. Click on the home button to go back to the System Select screen.

Click the "ALL DTC" button.

9. Perform an "Erase and Read All DTCs" again to clear any DTCs that may have set.
For instructions, refer to steps 6 and 7 in this TSB.
 - a. If any DTCs appear, troubleshoot per the applicable Service Manual.

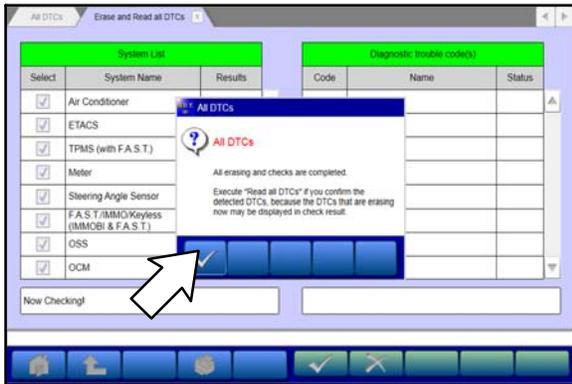
d. The "System List" on the left side of the screen will have all selections checked. **Do NOT** change these selections.

e. Click the check mark at the bottom of the page to continue.

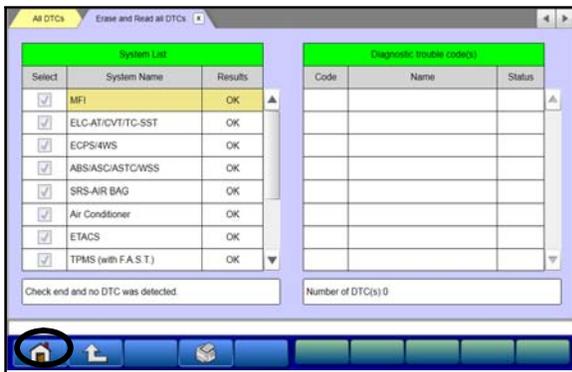
7. When DTC erasing is completed, click the check mark in the pop-up message that read "All erasing and checks are complete."

a. If DTCs return after erasing is completed, click the check mark to clear the window. Diagnose and repair per the Service Manual.

b. If DTCs do not return, click the check mark to clear the window, then click the Home icon in the lower left to return to the System Select menu.

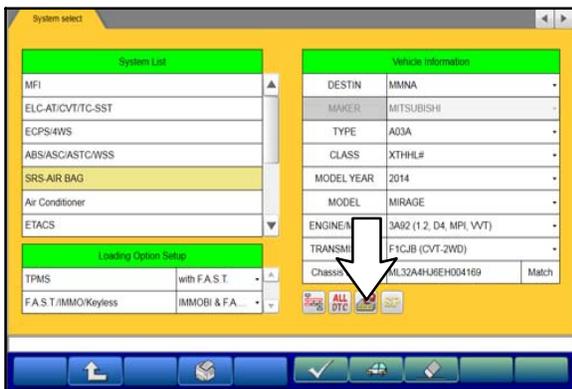
a. Click on the Reprogram button.

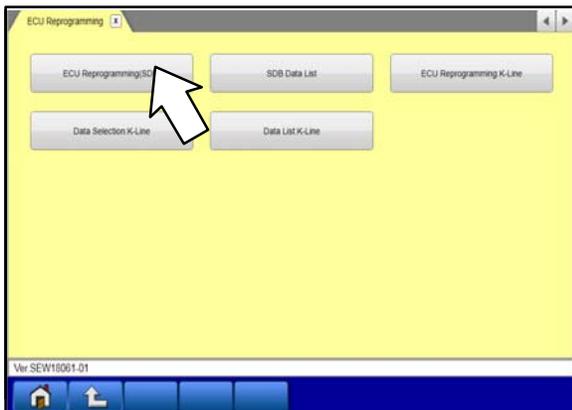
b. Select "ECU Reprogramming (SDB)."

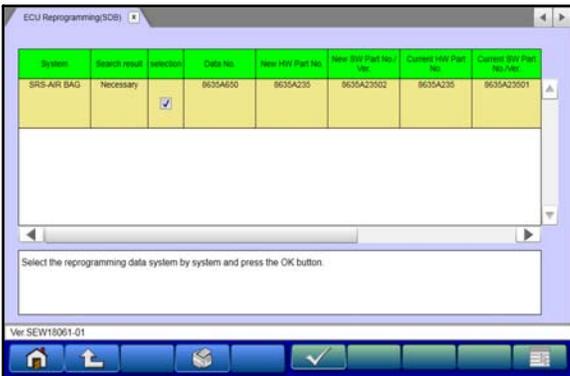
c. Verify the "SRS-ECU" is selected in the System List, then click the check mark at the bottom of the page.

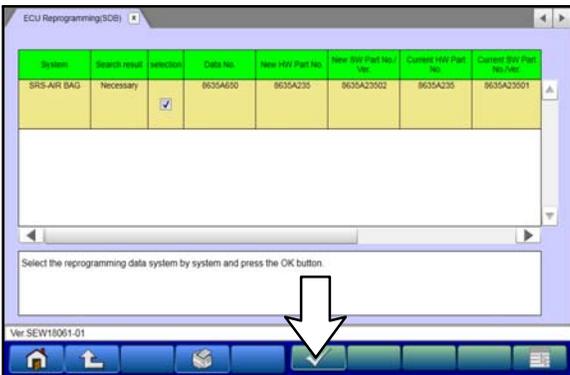
d. Verify the correct Data No. is listed in the "SRS-ECU Reprogramming Chart."

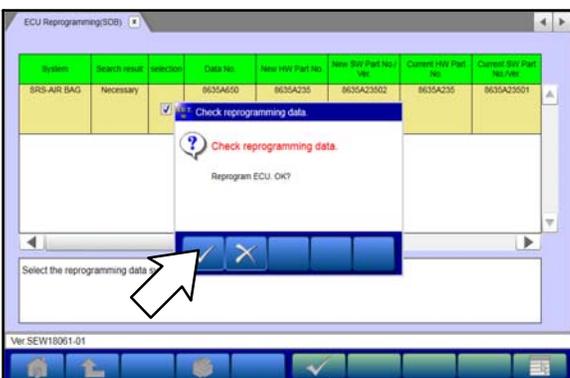
e. Click the check mark at the bottom of the page to initiate reprogramming.

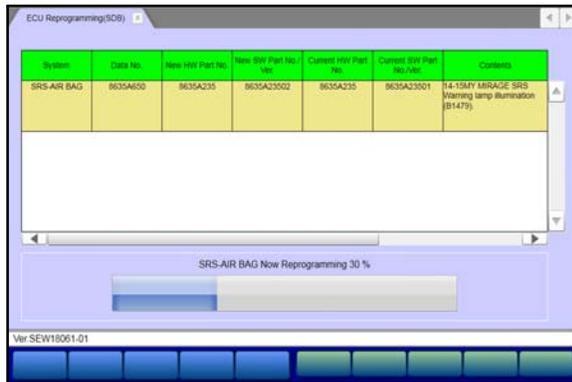
f. Click the check mark in the "Check reprogramming data" dialog box.

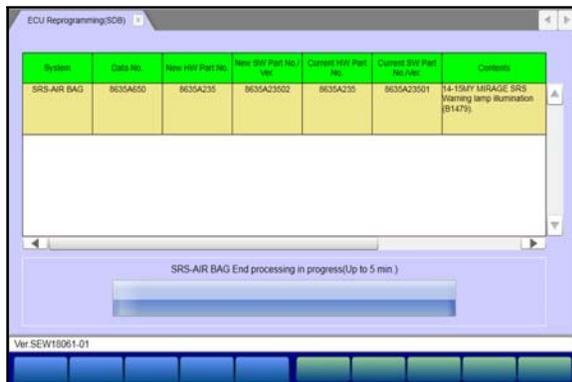
- g. Once the reprogramming is initiated, the screen shown will indicate the reprogramming progress.

Do NOT disturb the cables or turn off the ignition during reprogramming.

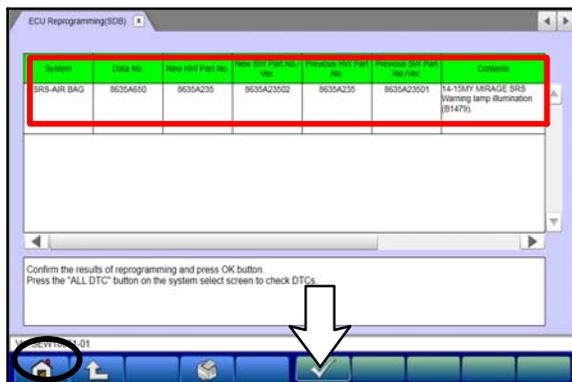
- h. Click the check mark in the "Completed" dialog box.

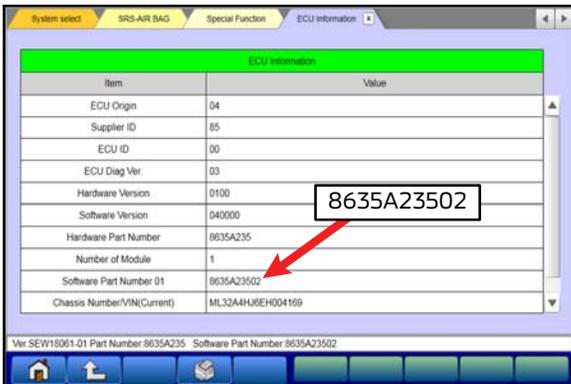
- i. Verify the correct information is listed in the table. Click the check mark at the bottom of the page, then click the Home button to return to the System Select screen.

- j. Click the home icon on the bottom of the page.
